# Appendix J of Lake Monroe Watershed Management Plan Detailed HUC-12 Water Quality Analysis by Subwatershed

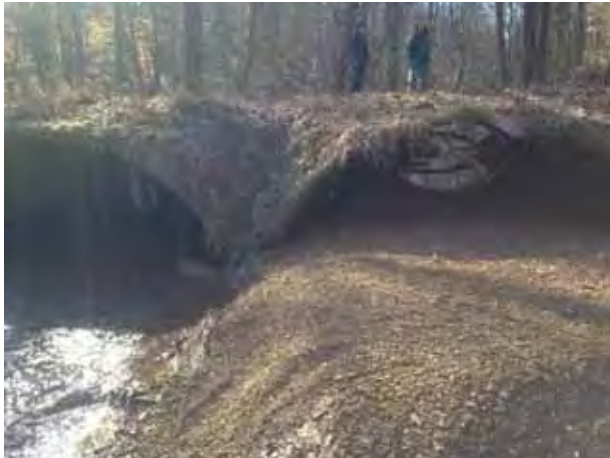
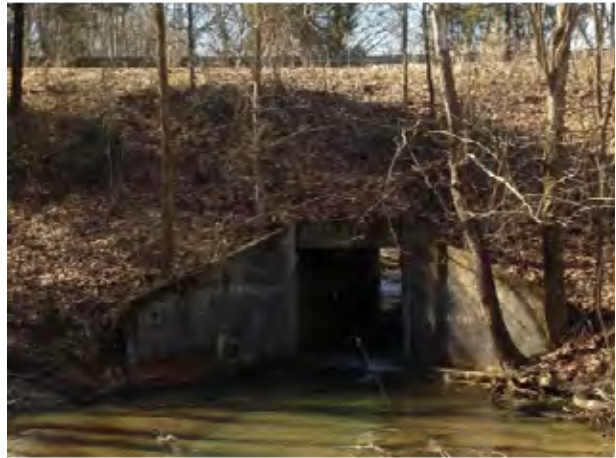
*Figure 1-12 Windshield Site 808 – County Road 825N over Callahan Branch. Double Culvert Slated for Replacement Due to Clogging*

During the windshield survey, we also noted that the United States Forest Service has been replacing some stream crossings to improve both hydrologic flow and stream biology. The two newest crossings were designed so aquatic wildlife could move easily upstream and downstream. This entails leaving the streambed intact and building a bridge with a wide span to preserve the full channel width, rather than putting in a culvert that restricts flow and can cut off the downstream section during periods of low flow. Two other crossings were identified for potential future projects. One is a double culvert that has collected large amounts of sediment. The other is a perched culvert where the culvert itself is an inch above the streambed on the downstream side so that during periods of low flow the stream is disconnected across the culvert. The new crossings are also more resistant to flooding and less likely to become blocked with debris.

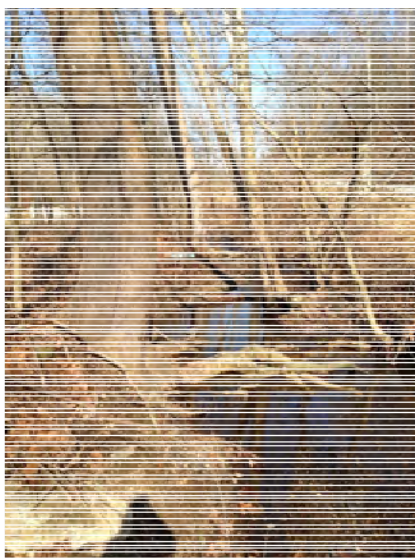
Figure 1-24 Site 355 Unnamed tributary to North Fork Salt Creek – lowest habitat scores

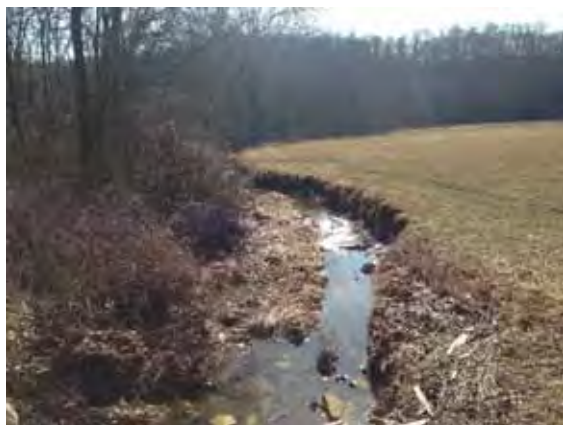
Figure 1-25 Site 488 on unnamed tributary to North Fork Salt Creek - most exceedances

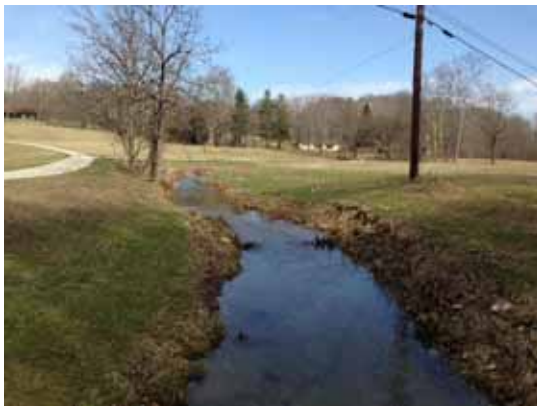
*Figure 1-29 Site 482 Showing No Riparian Buffer on Residential Property*

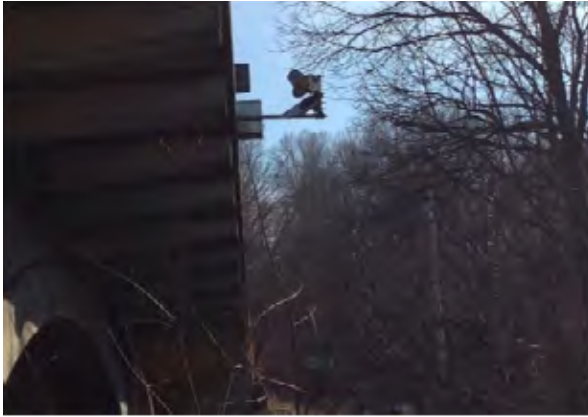
*Figure 1-30 Stream Gage on North Fork Salt Creek – State Road 46 Bridge Near Site 389*

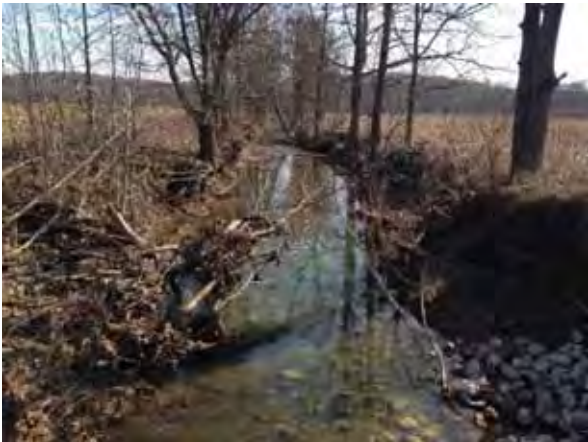
*Figure 1-31 Site 277 Showing Insufficient Riparian Buffer on Agricultural Property*

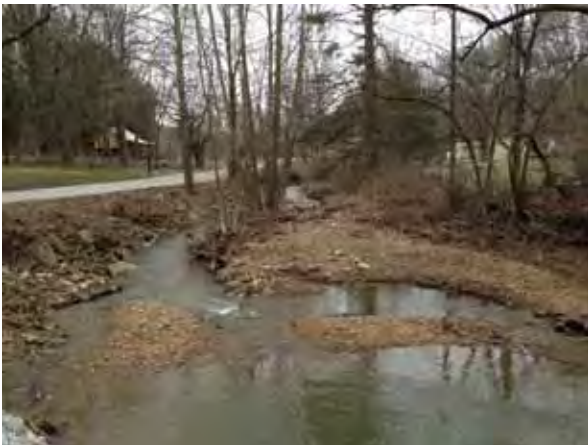
*Figure 1-32 Site 306 - Road Immediately Adjacent to Stream*

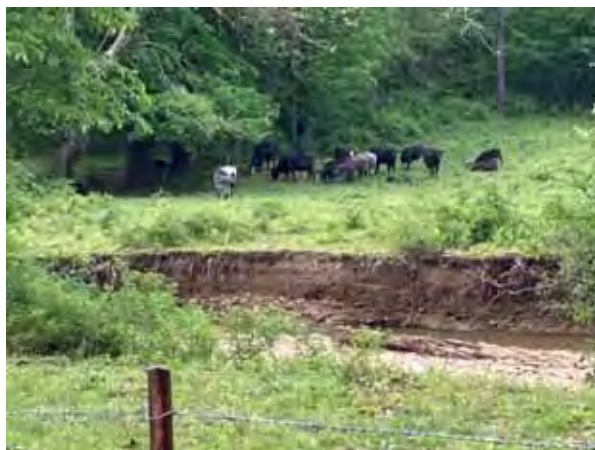
Figure 1-36 Site 467 - Livestock with Access to Baby Creek

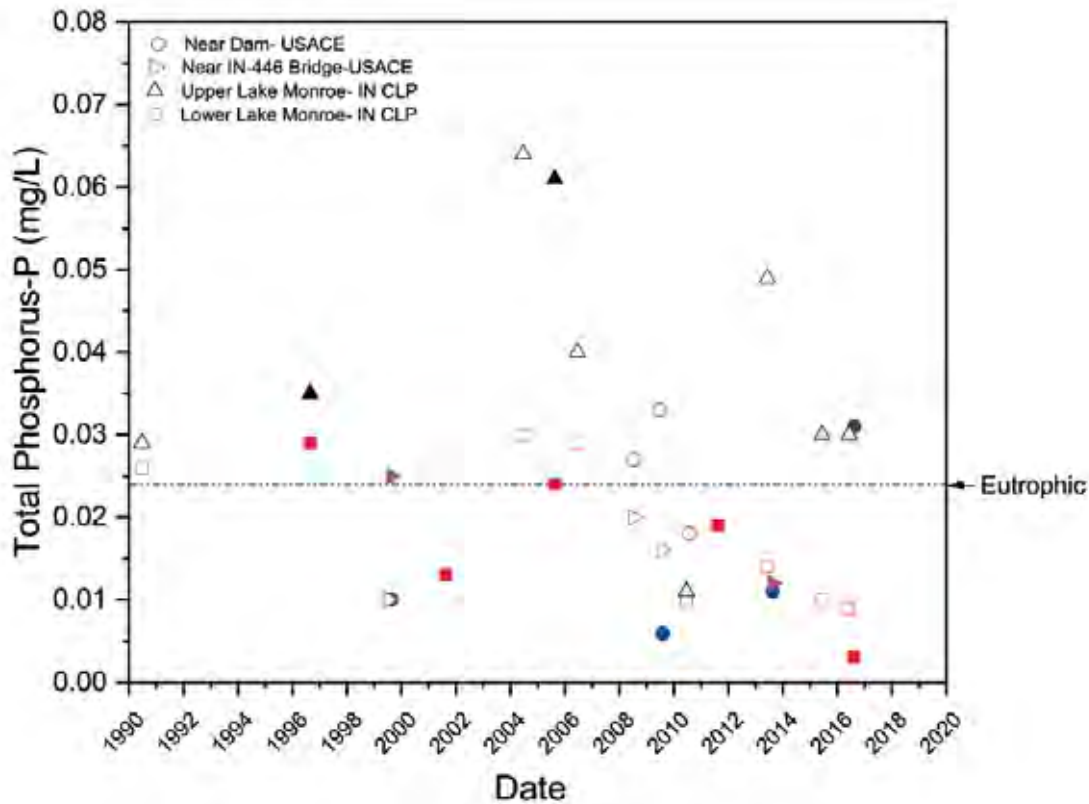
Figure 1-48 Historical Phosphorus Levels in Lake Monroe 1990-2017 (SPEA 2018)

A portion of the USACE data and Indiana Clean Lakes Program data collected between 1990 and 2017 was summarized by SPEA student Macayla Coleman in the 2018 report "Lake Monroe Water Quality Summary 1990-2017." The study focused on samples collected during the summer stratification period from the three basins. These data were used to calculate the trophic state index (TSI) based on different sampling parameters. Total Phosphorus concentrations ranged widely from approximately 0.004 mg/L to 0.064 mg/L. Using the Carlson (1977) standard of 0.024 mg/L (shown in the diagram), 44% of the measurements meet or exceed the eutrophic threshold.

Measurements of Secchi disk transparency and chlorophyll-a also exceeded the eutrophic threshold in about half the samples. The study concluded that Lake Monroe appears to be mildly eutrophic and that algal blooms could be affecting water quality.

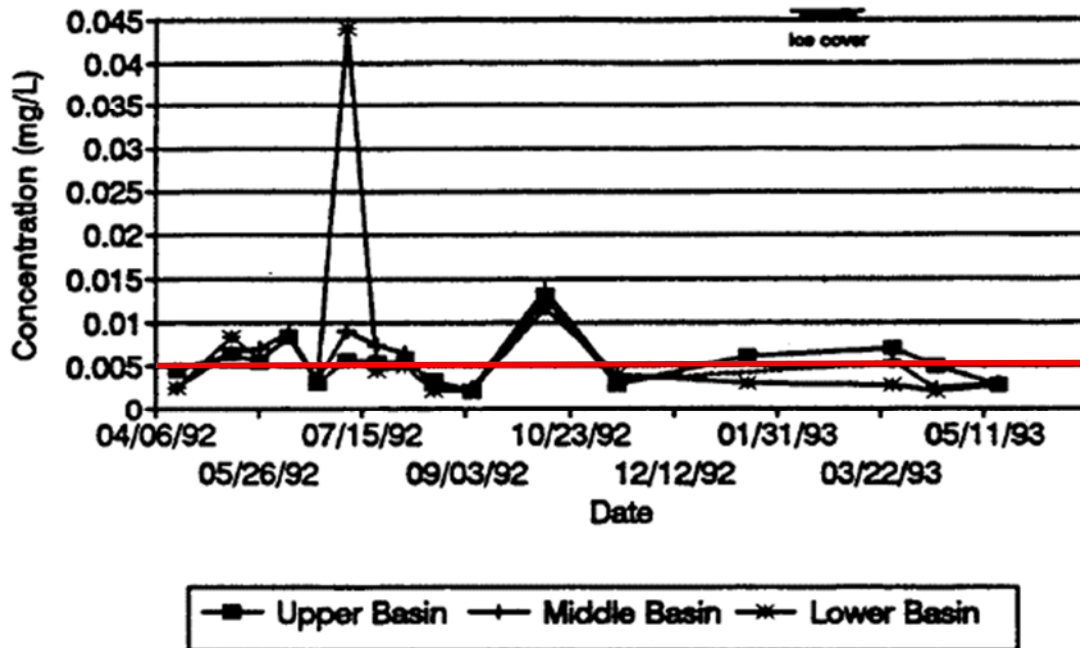
Figure 1-50 Historical Soluble Reactive Phosphorus in Lake Monroe (Jones Study 1997: Figure 5-17. Soluble Reactive Phosphorus – Lake Basin Means)

Soluble reactive phosphorus (SRP) concentrations in Lake Monroe also regularly exceeded the water quality target of 0.005 mg/L. Two spikes in particular were noted. One occurred in the October 1992 when all three basins had average SRP concentration around 0.012 mg/L, more than twice the target level. This spike is believed to be result of die-back from Eurasian water milfoil, which released SRP from the decaying plant tissue. The other spike in SRP that was reported for the lower basin in June 1992 is believed to be an analytical error.

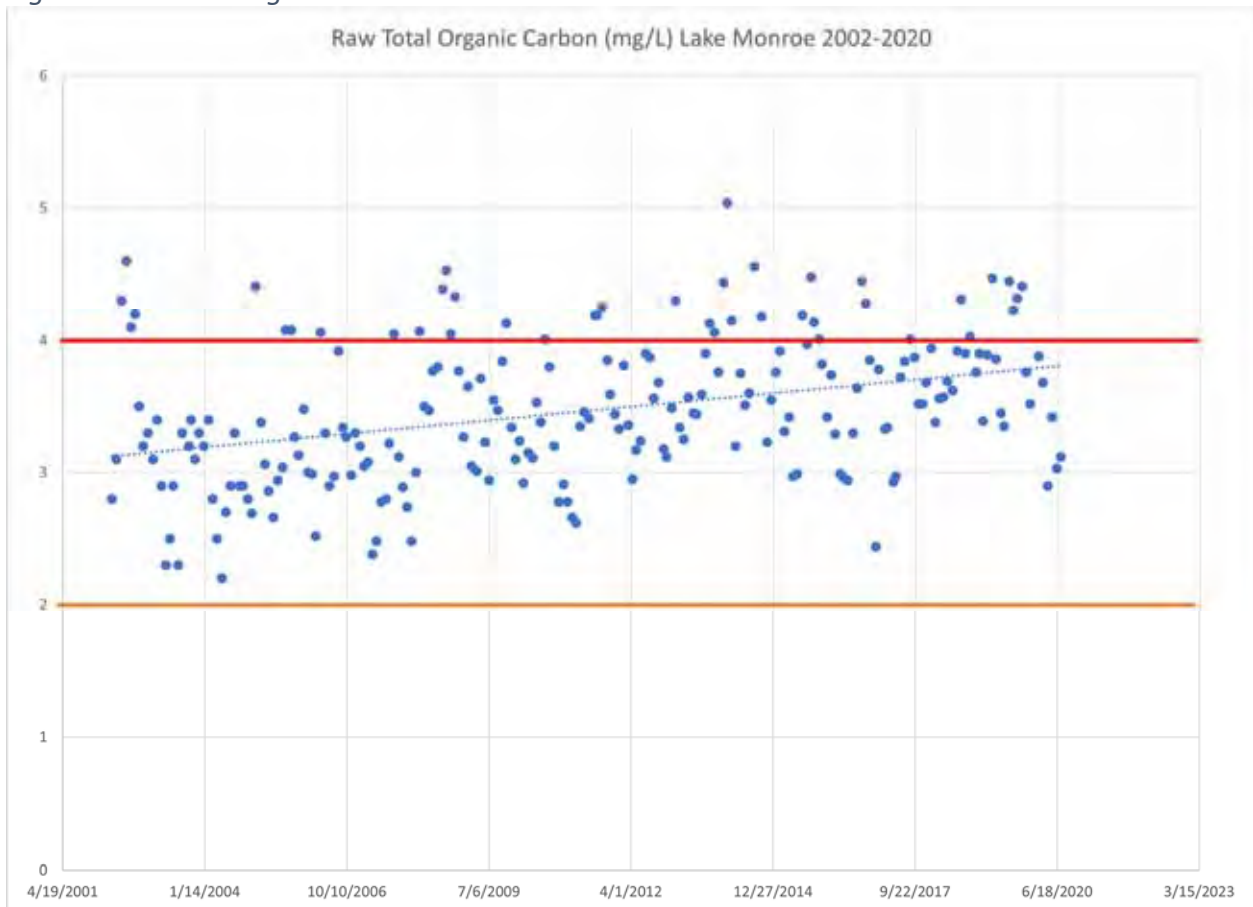
Figure 1-51 Total Organic Carbon in Raw Lake Monroe Water 2002-2020

CBU conducts a variety of tests on water from Lake Monroe as part of their drinking water treatment program. Three frequently monitored parameters are Total Organic Carbon, Dissolved Organic Carbon, and UV254. These parameters are different ways of measuring organic matter in the water. Increasing organic matter decreases water clarity, turning the water brown. Organic matter can also react with chlorine to create toxic disinfection byproducts, meaning that water with higher concentrations of organic matter requires additional pre-treatment steps before chlorine is added as part of the drinking water treatment process.
