Lake Monroe Watershed Management Plan, 2022: Executive Summary

March 2022

Friends of Lake Monroe has published a watershed management plan

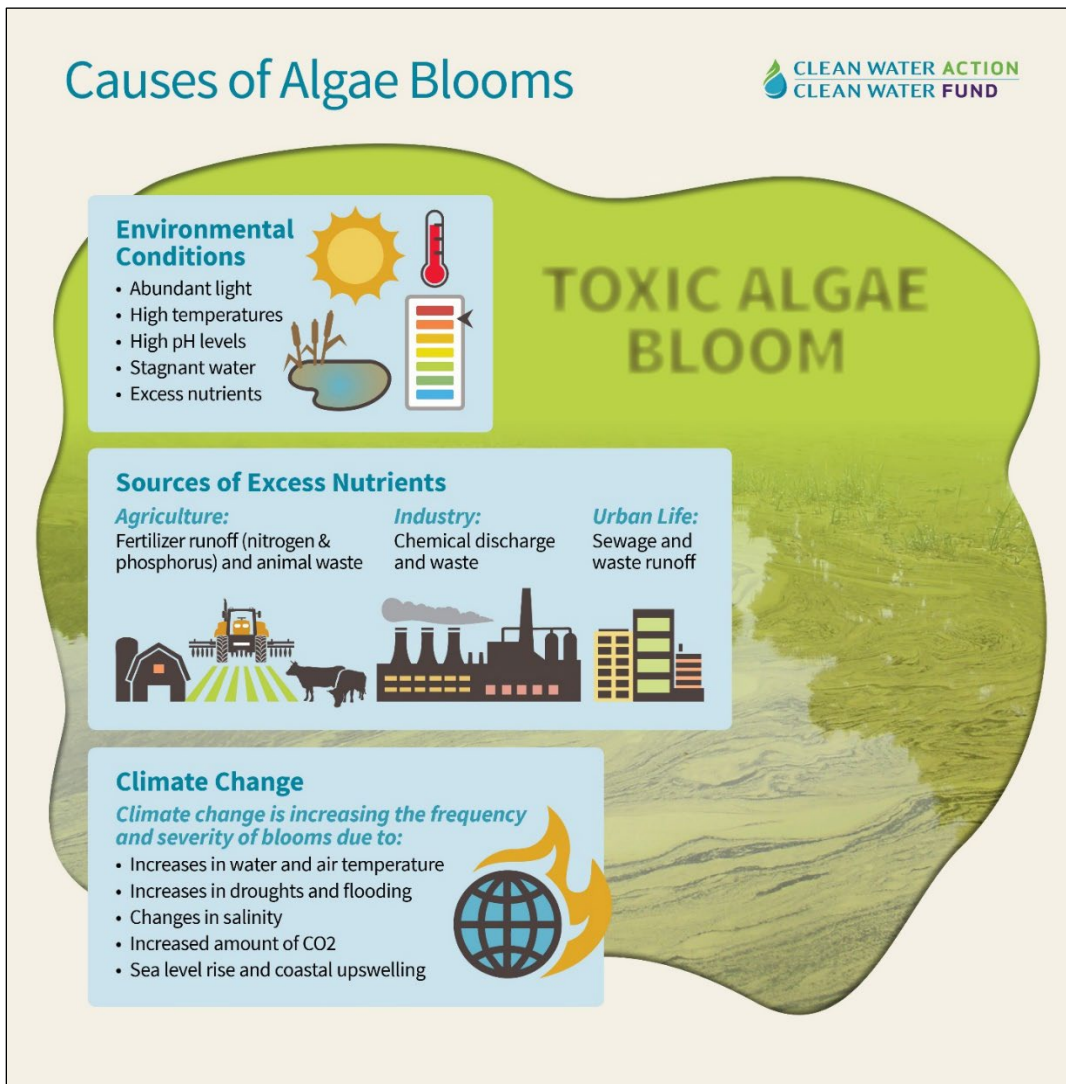
Lakes with phosphorus concentrations over 20 µg/L are considered eutrophic and can be expected to have more severe and frequent algal blooms. Phosphorus concentrations in Lake Monroe historically and today are regularly above that threshold. North Fork Salt Creek appears to be the largest contributor of phosphorus with the South Fork not far behind. Potential sources of phosphorus include fertilizer (from agricultural, commercial, or residential usage), animal manure, septic system leachate, and sediment.

Elevated nitrogen concentrations also increase the likelihood of harmful algal blooms. Nitrogen levels in Lake Monroe were above target levels in more than half of the 2020 samples. South Fork Salt Creek appears to be the largest contributor of nitrogen by a significant margin. This correlates strongly with the fact that the South Fork sub-watershed has the highest percentage of agricultural land. Potential sources of nitrogen include fertilizer, animal manure, septic system leachate, and sediment.

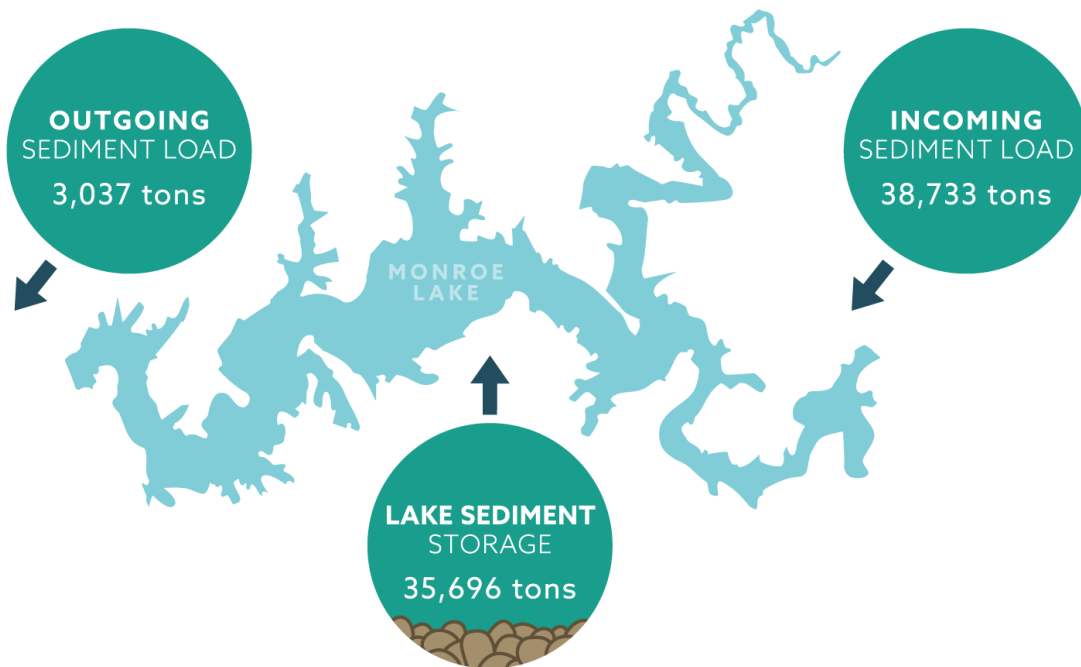
Water quality monitoring in Lake Monroe showed generally low levels of total suspended solids. However, monitoring of the main tributaries and the outlet of the lake showed that significant volumes of sediment are accumulating in the lake. Lake Monroe retains almost 92% of the sediment that enters, with an estimated accumulation rate of 35,696 tons per year. The North Fork sub-watershed appears to be the largest contributor of sediment.

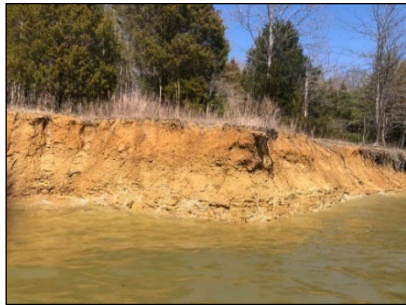
Approximately 76% of the Lake Monroe watershed is considered highly erodible due to its steep slopes and soil type. One potential source of sediment is streambank erosion, which was documented at 86% of observed stream sites. Another potential source is conventionally tilled cropland. There are roughly 10,000 acres of cropland (4% of the watershed) and conventional tillage is still commonly practiced. Other potential sources of sediment include livestock with free access to streams, construction sites with insufficient erosion control, and forestry sites with insufficient erosion control.

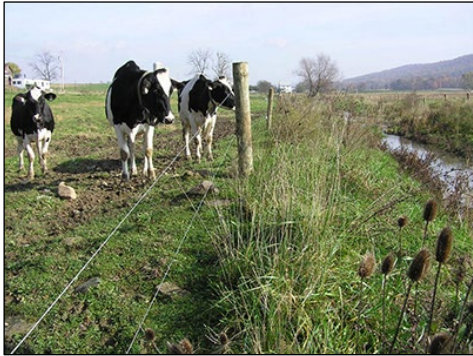
Livestock are one potential source of nutrients and bacteria. This source can be addressed by increasing the use of conservation practices like fencing livestock out of streams (as shown in photo to the left), installing heavy use area protection, and improving manure management. Streams can be further protected by planting pollinator habitat or trees along streams to create a riparian buffer that filters runoff before it reaches the stream and helps stabilize the stream banks.

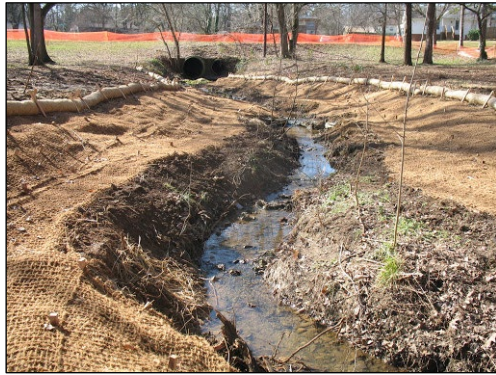
While some erosion of stream banks is inevitable (streams by nature move sediment downstream), human activities in the watershed can increase the volume of sediment being transported. Fluctuations in water level within the lake are also believed to directly exacerbate erosion of both the lakeshore and the stream banks. Strategies to address stream bank and lakeshore erosion include stabilization in areas where erosion is severe, fencing livestock out of streams, installing riparian buffers of permanent vegetation along stream banks,

adding vegetation to existing riprap, and instituting operational changes at the dam that would reduce water level fluctuations in Lake Monroe.
